Tektronix 49x/275x/279x-Series Spectrum Analyzer Service Notes

**John Miles, KE5FX
john@miles.io**

Aug 4, 2019

Errata and helpful notes on calibration/service procedures

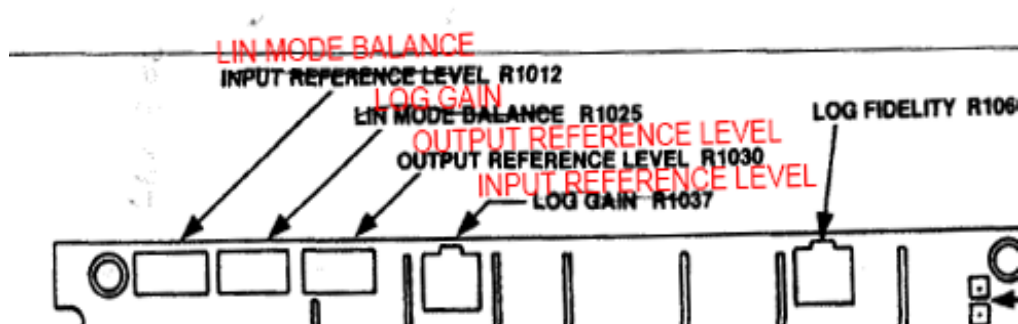
The catch is that at least two different layouts were used for the controls in figure 5-13. At some point, probably around the time Tek redesigned the board using surface-mount components in the late 1980s-early 1990s, the trimmer functions were reordered *while their physical locations were left alone*. In earlier logamp assemblies, the order is as specified (left-to-right on the component side):

INPUT REFERENCE LEVEL R1012
LIN MODE BALANCE R1025
OUTPUT REFERENCE LEVEL R1030
LOG GAIN R1037
LOG FIDELITY R1060 (also called "log linearity" in some manuals)

In later assemblies, the correct control order is:

LIN MODE BALANCE R1025
LOG GAIN R1037
OUTPUT REFERENCE LEVEL R1030
INPUT REFERENCE LEVEL R1012
LOG FIDELITY R1060

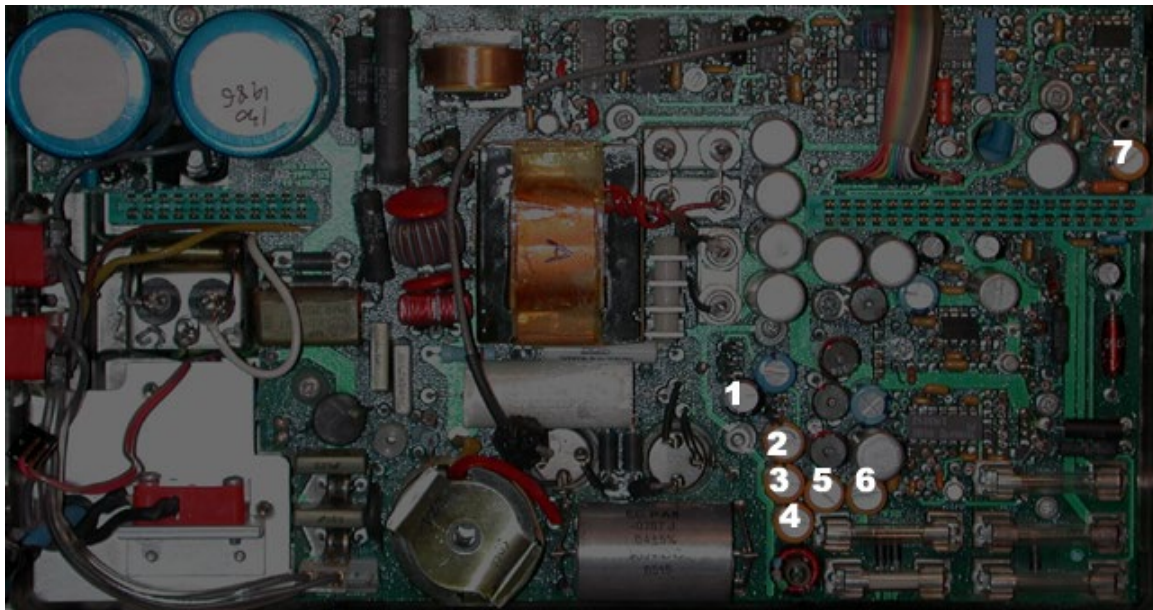
Regulation tolerances for the low-voltage supply buses are specified in service volume 1, and are not usually a problem. However, the +100V and +300V supplies are frequently below their specified values. If any 66-kHz ripple or sagging is observed, all of the miniature 2.2 uF/200V axial-lead electrolytic capacitors in the power supply should be replaced. These are inexpensive high-failure-rate parts, so they should be replaced in any event if the power supply is otherwise disassembled for service.

I recommend checking the ESR on any replacement high-voltage electrolytics as well. Several "new" capacitors in this voltage range have proven defective when obtained from surplus sources.

High ESR in the filter capacitors on the lower-voltage rails (+17V, +5V) has been reported as a cause of excessive power-supply temperature, so when servicing the power supply, you should check ESR on *all* electrolytics as a matter of habit. Check heat-sink fasteners for tightness, and renew the heat-sink compound while you're at it. Avoid losing track of the mica washers and aluminum spacers that may fall out when you remove the PCB.

Use 105 degree C-rated electrolytics where possible, e.g., 3.3 uF 350V 105C, [Digi-Key](#) part # 493-2046-ND. These can replace all of the smaller high-voltage capacitors in the power supply (6x 2.2uF/200V, 1x 1uF/350V).

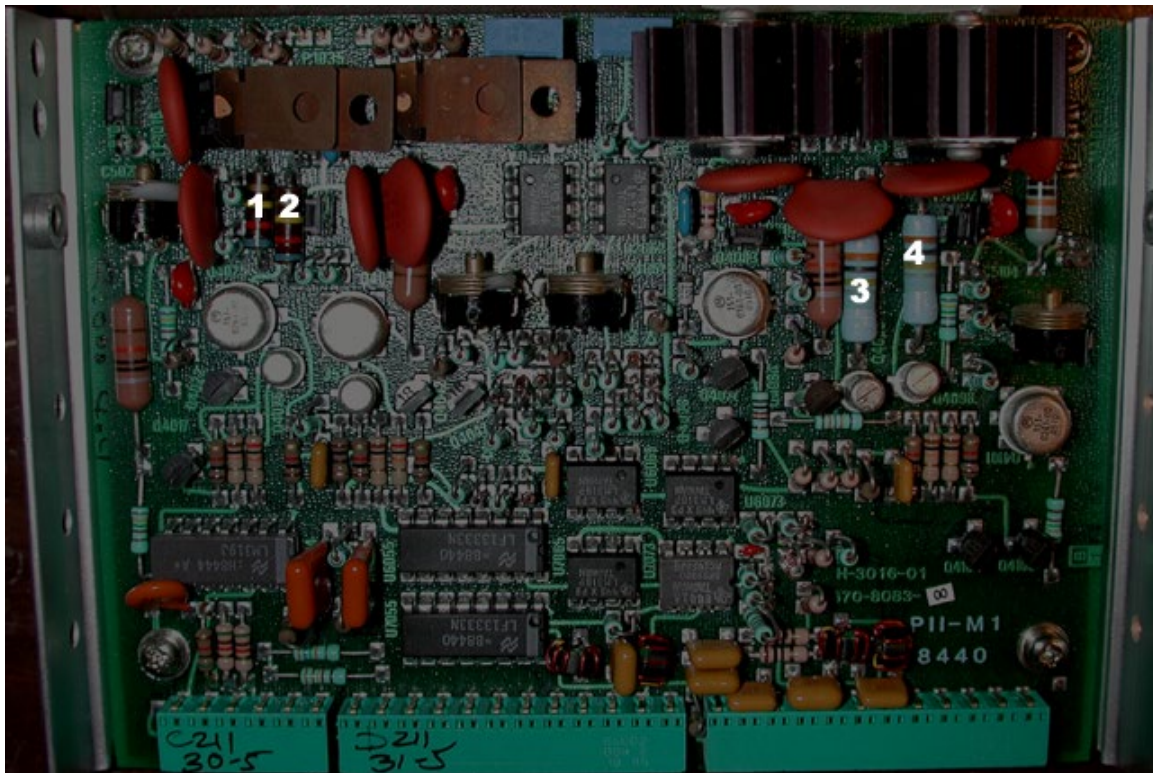
As with the small high-voltage electrolytic capacitors in the power supply, it's a good idea to check the resistance of any new carbon composition resistors that you order. Brand-new parts have been reported out of spec. Carbon film or metal film parts are preferable. This particular board already had 300K metal film resistors (3,4) in place, so they were left alone. The original 620K, 5% carbon-composition resistors (1,2) were measured at 580K and 980K, respectively.

When servicing instruments with the pre-1988 deflection amplifiers, it's a good idea to replace the 620K and 300K carbon-composition resistors in the negative-feedback paths. Many of these resistors have drifted upward over time, and/or become noisy. Typical replacement parts would be [Digi-Key](#) P620KBBCT-ND (two each) and BC300KW-2CT-ND (two each). Calibrate the deflection amplifier and digital storage subassemblies after replacing these resistors.

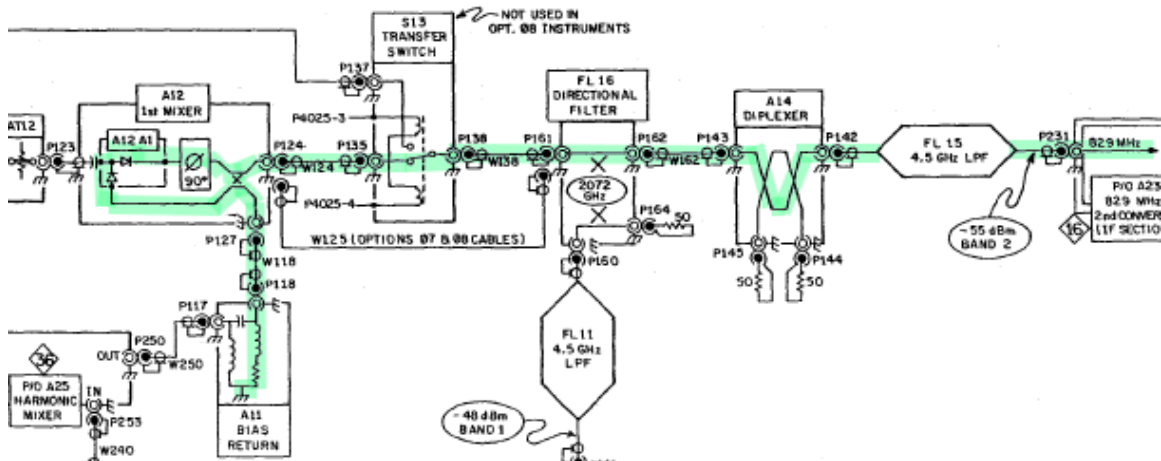
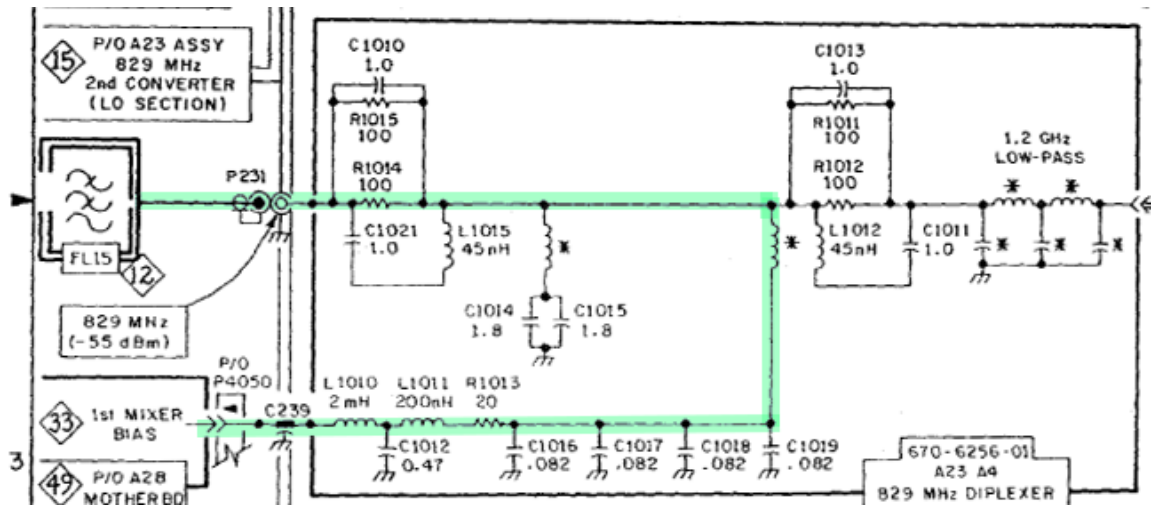
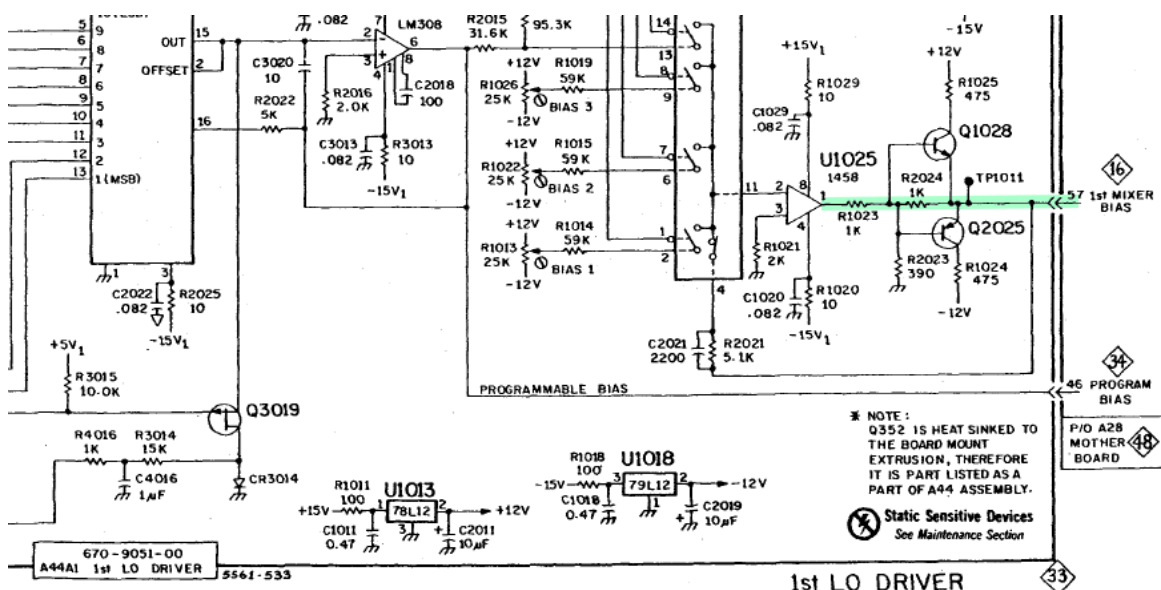
Before condemning the first mixer in the 21 GHz analyzers, for instance, make sure the DC bias path from the LO driver board to the mixer bias termination is OK. The front-end mixers in the 1.8 GHz analyzers were operated at zero bias, but the 21 GHz models used a circuitous bias path with several potential points of failure. Excerpts from the 494AP schematics appear below with the first mixer bias path highlighted in green.

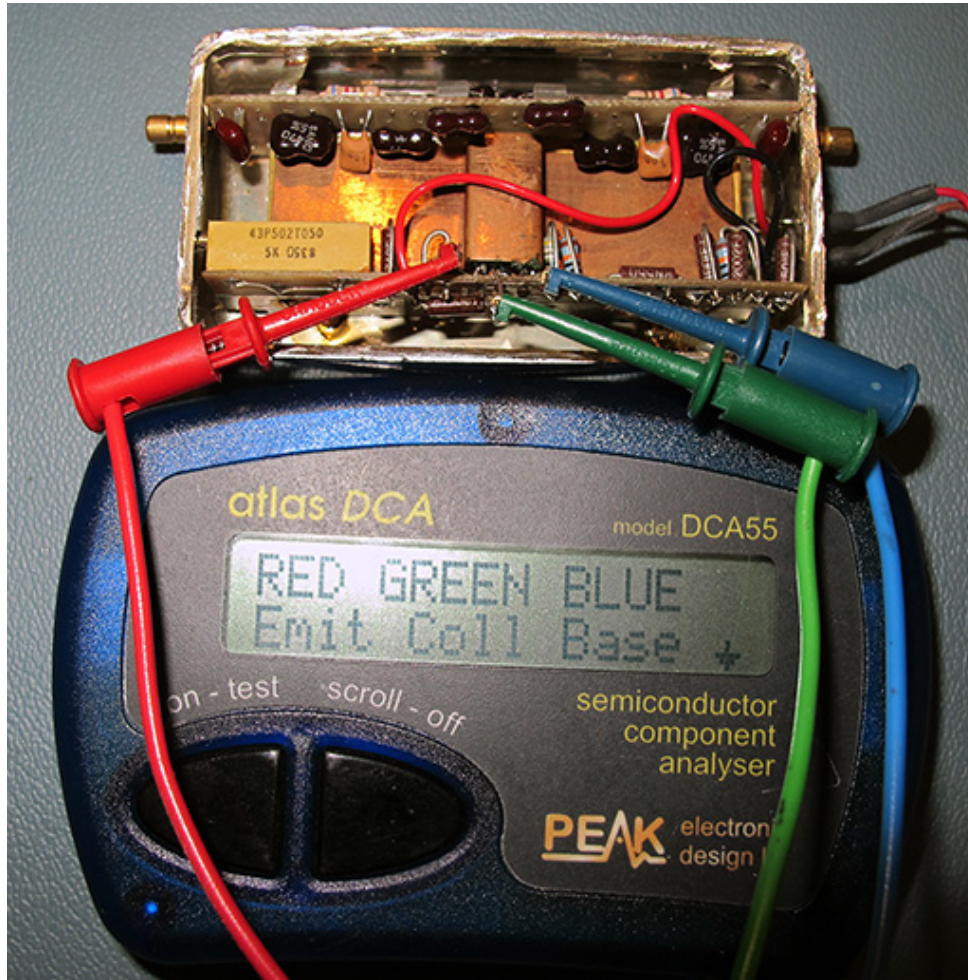
The signal paths used for the 30 Hz and 100 Hz resolution bandwidths in these models used an ovenized crystal filter. This filter is mounted above the CRT. It can reach 60-70 degrees C in normal operation – too hot to touch for more than a few seconds. If the filter housing fails to warm up, the pass transistor in the oven control loop has probably failed.

The pass transistor is bonded to a copper “heat sink” that’s in contact with the oven heating coil wrapped around the crystals. The intent may have been to use the transistor as part of the heating element to achieve faster warmup time. This practice is common in oscillator oven circuits, but in this case it seems to have contributed to reliability problems. By the time the analyzer has accumulated a few thousand operating hours many of these transistors will have failed.

In the photo above, one of the lucky ones is being characterized by a pocket semiconductor tester. The part was identified as an NPN silicon bipolar transistor with a beta of 110. I’ve used 2SC1847s to replace these transistors, but any similar part should be fine. I recommend bolting the replacement part to the side of the filter housing, rather than installing it in the original location under the copper strip.

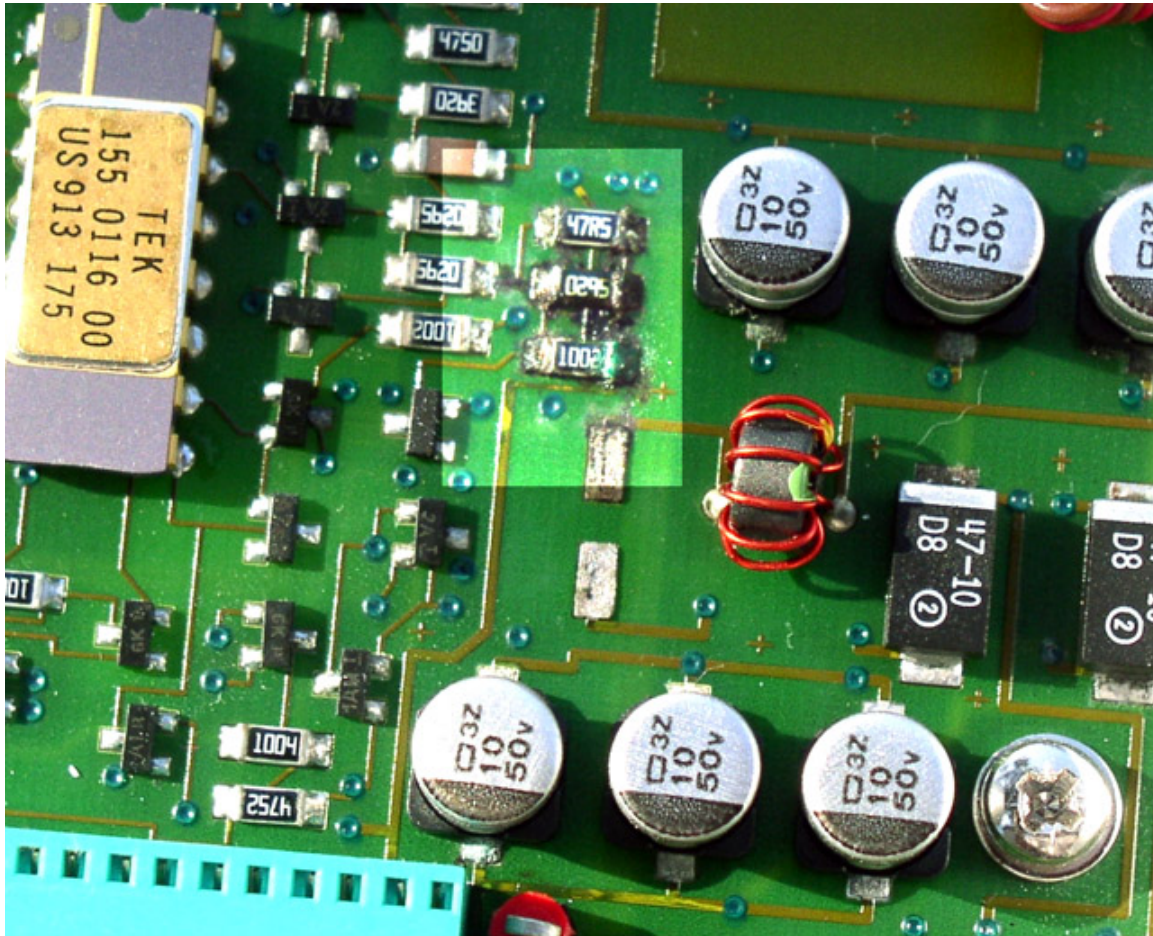
Amplitude instability in the newer units (e.g., later-production 494APs, as well as 495Ps with serial numbers after B030000) is becoming all too common, thanks to Tek's eagerness to adopt surface-mount technology at a time when component quality wasn't yet up to par with traditional through-hole tech. If you own one of these early-1990s vintage analyzers, chances are good that your logamp board (in particular) already looks like this:

The black “crud” in the highlighted area doesn’t originate from the resistors or from the soldering or assembly process. Rather, it’s caused by outgassing of corrosive vapors from one or more of the 10 uF/50V electrolytics nearby. Any corroded traces should be cleaned or bridged as soon as you spot the problem, and *all* of the aluminum-can electrolytics should be replaced.

50-volt capacitors aren’t needed in most cases -- 35V is fine for supply buses up to +/-15 volt -- and their exact type (tantalum or aluminum) isn’t important either. **Just get those old caps off the board!** Keep in mind that affected traces can be several inches away from the nearest capacitor. A careful inspection of the entire PCB is necessary when this failure occurs.

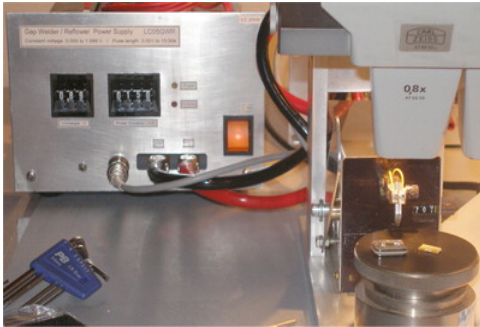
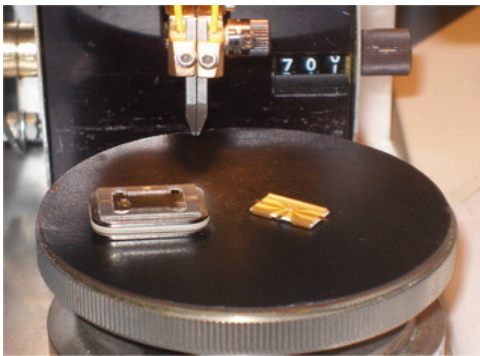
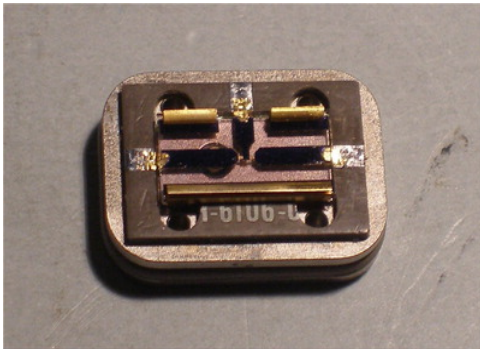
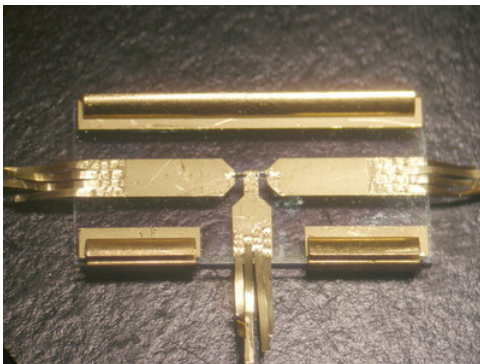
Photos courtesy Luis Cupido, CT1DMK, of the [chip-hybrids](#) group, showing the diode carrier from the 21 GHz first mixer with its substrate removed, undergoing diode replacement.

The mixer diodes themselves are almost too small to see, even in the magnified view at bottom. Actual width of the entire substrate is approximately 15 mm.
