***Tektronix 49x/275x/279x-Series Spectrum Analyzer  
Service Notes***

**John Miles, KE5FX  
john@miles.io**

**April 23, 2016**

## ***Errata and helpful notes on calibration/service procedures***

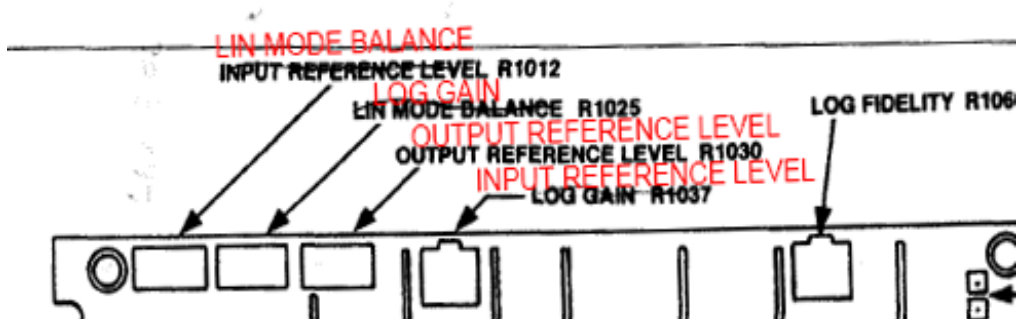
The catch is that at least two different layouts were used for the controls in figure 5-13. At some point, probably around the time Tek redesigned the board using surface-mount components in the late 1980s-early 1990s, the trimmer functions were reordered *while their physical locations were left alone*. In earlier logamp assemblies, the order is as specified (left-to-right on the component side):

INPUT REFERENCE LEVEL R1012  
LIN MODE BALANCE R1025  
OUTPUT REFERENCE LEVEL R1030  
LOG GAIN R1037  
LOG FIDELITY R1060 (also called "log linearity" in some manuals)

In later assemblies, the correct control order is:

LIN MODE BALANCE R1025  
LOG GAIN R1037  
OUTPUT REFERENCE LEVEL R1030  
INPUT REFERENCE LEVEL R1012  
LOG FIDELITY R1060

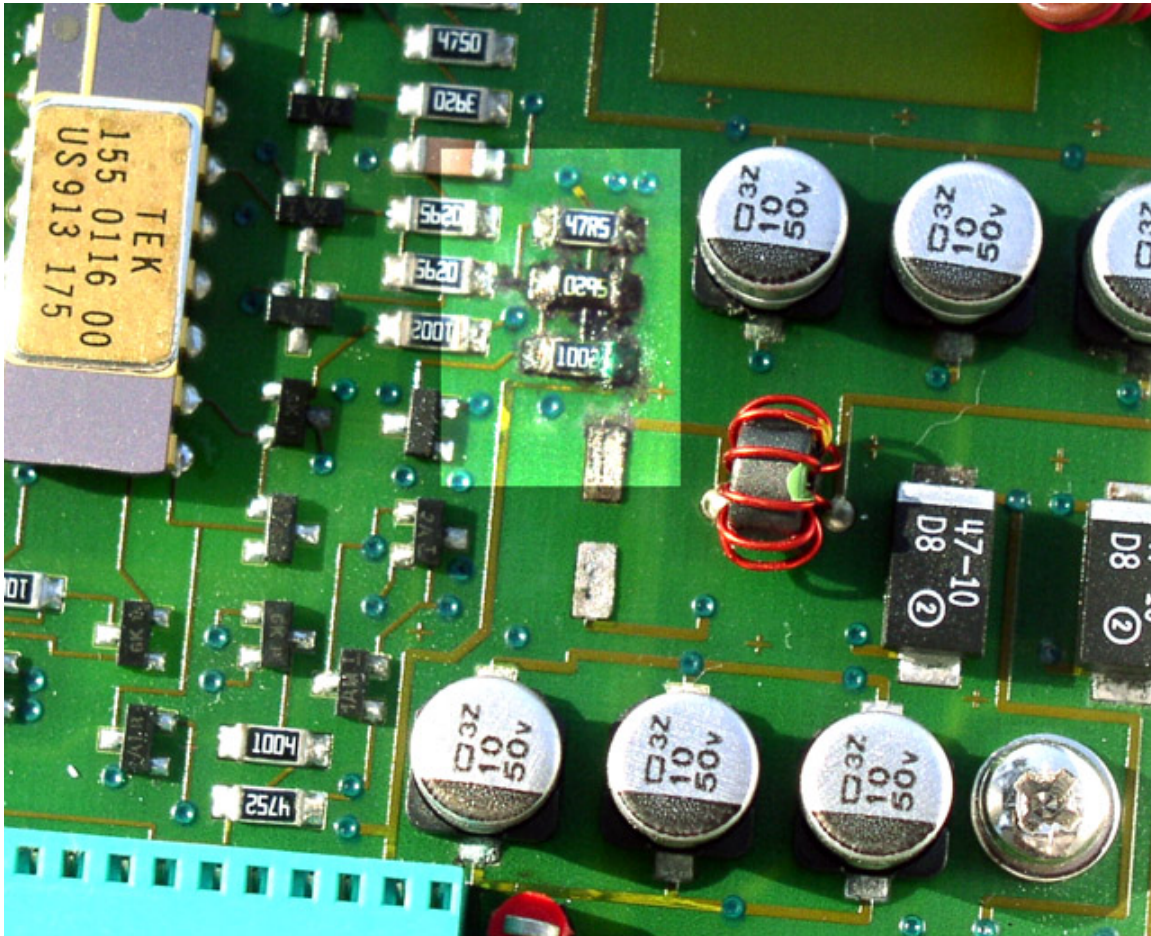
Amplitude instability in the newer units (e.g, later-production 494APs, as well as 495Ps with serial numbers after B030000) is becoming all too common, thanks to Tek's eagerness to adopt surface-mount technology at a time when component quality wasn't yet up to par with traditional through-hole tech. If you own one of these early-1990s vintage analyzers, chances are good that your log amp board (in particular) already looks like this:

The black "crud" in the highlighted area doesn't originate from the resistors or from the soldering or assembly process. Rather, it's caused by outgassing of corrosive vapors from one or more of the 10 uF/50V electrolytics nearby. Any corroded traces should be cleaned or bridged as soon as you spot the problem, and *all* of the aluminum-can electrolytics should be replaced.

50-volt capacitors aren't needed in most cases -- 35V is fine for supply buses up to +/-15 volt -- and their exact type (tantalum or aluminum) isn't important either. **Just get those old caps off the board!** Keep in mind that affected traces can be several inches away from the nearest capacitor. A careful inspection of the entire PCB is necessary when this failure occurs.

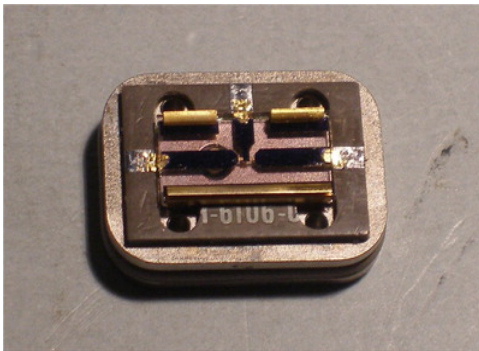
Photos courtesy Luis Cupido, CT1DMK, of the [chip-hybrids](#) group, showing the diode carrier from the 21 GHz first mixer with its substrate removed, undergoing diode replacement.

The mixer diodes themselves are almost too small to see, even in the magnified view at bottom. Actual width of the entire substrate is approximately 15 mm.

It's been reported by Luis Cupido, CT1DMK that the beam-lead diodes can be replaced with either BAT30 low-barrier parts from Infineon or MSKN709 medium-barrier diodes from Metelics. Low-barrier Metelics parts should also be usable, as may similar diodes from MA/COM. Luis has found that the better-known HCSC9101 diodes need more LO power than the analyzer has available.

Although the mixer and its diode carrier are easy to work with on the bench, replacing the diodes on the carrier is another matter. Gap-welding capabilities are required for the gold ribbon-to-substrate attachment, while gap reflowing is used to attach the ribbons to the diode holder (although the latter operation may be performed with a small soldering iron). It may be difficult to preserve the original gold ribbons during disassembly; be prepared to replace them with new ribbon stock.
