This document recounts an experimental procedure undertaken to replenish the molecular hydrogen reservoir in my VCH-1006 passive maser.

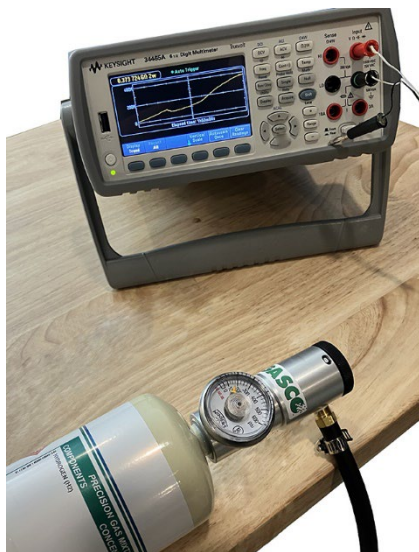
Prior experience had shown that cranking up the temperature in the canister containing the lanthanum nickel hydride storage media was a temporary fix at best, so it was time for more drastic measures.

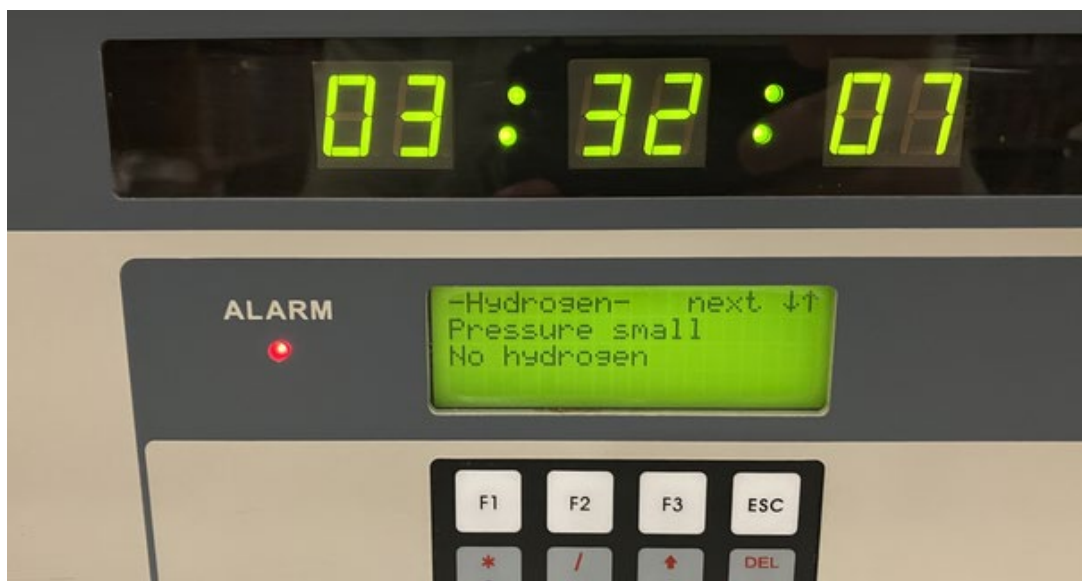
The maser has been working well for over a year, but given that it's almost 25 years old judging by component date codes in the 2000-2001 timeframe, it was clear that it would need a hydrogen refill in the not-too-distant future. In mid-August 2025, the H₂ pressure fell below its rated 1.5-atm minimum.

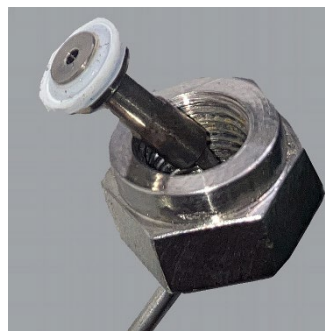
It's possible that the H₂ lines were open to air for one to two hours before I noticed the missing tape. I switched to a piece of heavy-duty copper tape with a much stronger adhesive while I waited for the hose connection pieces to arrive overnight.

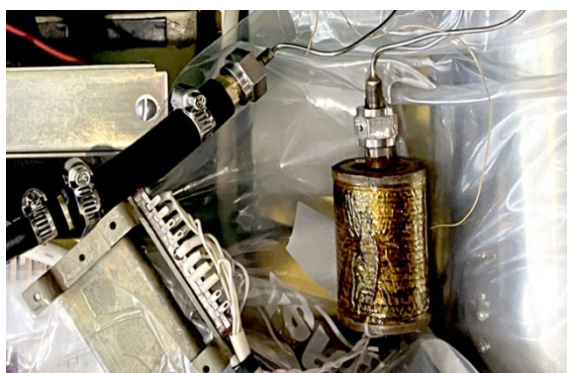
Upon turning on the gas for a trial run at room temperature, my initial impression was unsettling. Most literature indicates that the gas-absorption process is noticeably exothermic, requiring cooling during the refilling process to keep the reaction going. But the canister didn't seem to warm up. A DMM connected to the thermistor at pins 3 and 4 of the associated connector did not indicate any internal temperature rise at all.

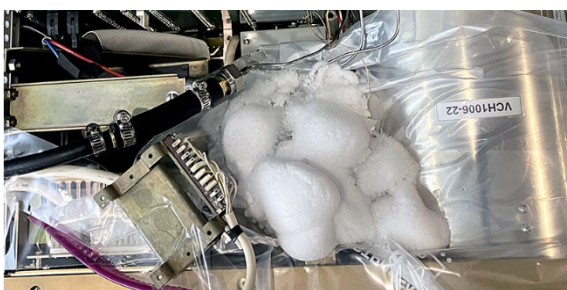
The next phase of the plan was to chill the hydride canister with dry ice....
