Tektronix 49x/275x/279x-Series Spectrum Analyzer Service Notes

**John Miles, KE5FX
john@miles.io**

Aug 4, 2019

Errata and helpful notes on calibration/service procedures

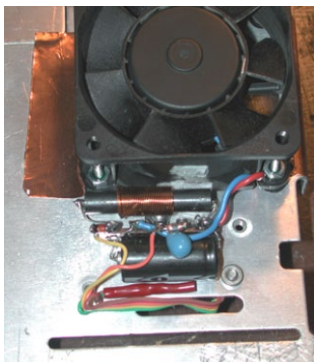
A more subtle consequence of using a replacement fan is extended warm-up time for the entire analyzer, assuming the fan is no longer temperature-controlled.

Similarly, careful electrical isolation is needed to maintain the instrument's original performance. Twist the fan leads together and keep them as short as possible. Bypass the fan with a parallel combination of a large (470 to 1000 uF) electrolytic capacitor and smaller tantalum capacitor (~10 uF), and use a series choke with a value of 100 uH or more that's rated for the fan's supply current.

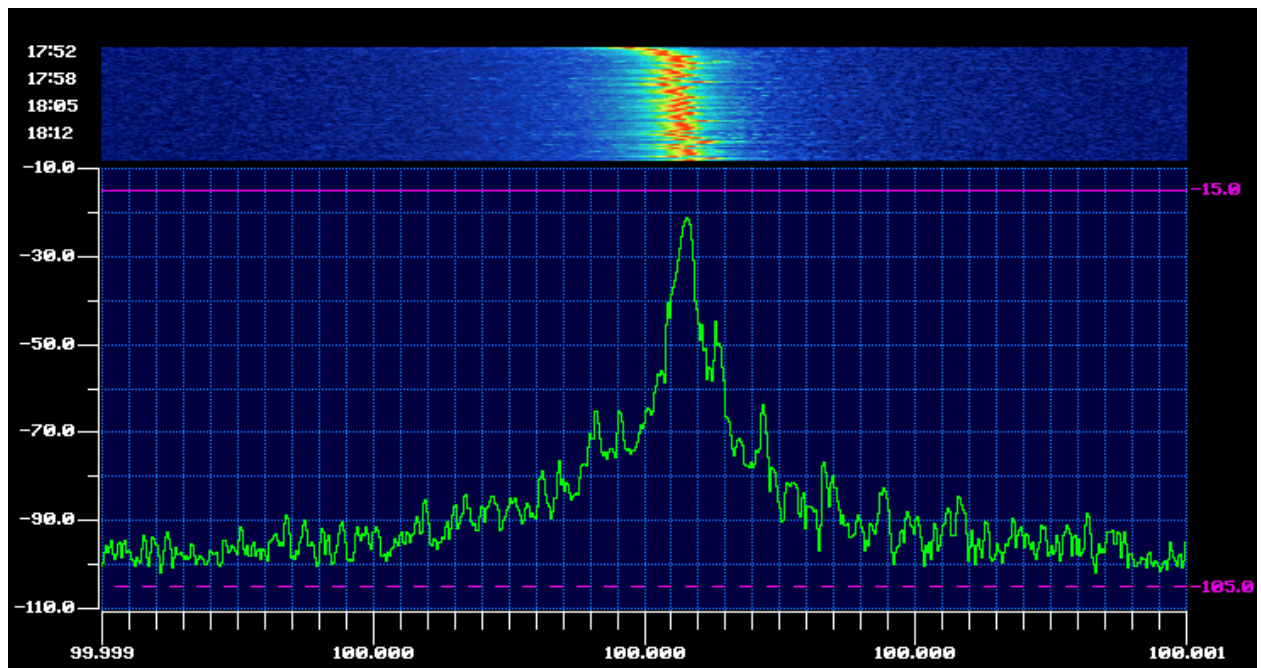
It is less common to see excess noise at narrowband (less than 10 kHz) offsets. (See the graphs at the end of this document for an idea of what to expect from your analyzer.) One stage that can contribute to close-in noise is the synthesized 2nd LO module found in post-B030000 492s and later models. If your calibrator signal looks like the one shown below, taken from a 494AP at 10 Hz RBW, the 2nd LO is worth investigating.

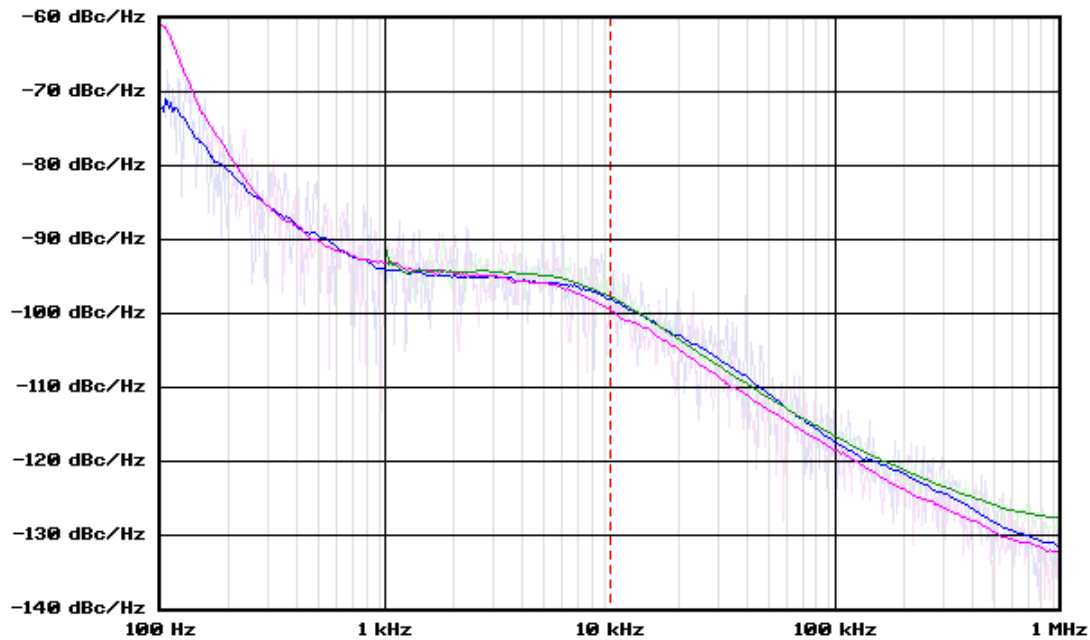
The traces below were acquired with PN.EXE from the GPIB Toolkit, measuring the output of a Wenzel crystal oscillator whose phase noise is substantially lower than the analyzers' own. Typical examples of the 494AP, 494P, and 492P spectrum analyzers were compared. Minimum RF attenuation was set to 0 dB in all three cases, and 20 dB of carrier clipping was used.
