***Tektronix 49x/275x/279x-Series Spectrum Analyzer  
Service Notes***

**John Miles, KE5FX  
john@miles.io**

**April 23, 2016**

## ***Errata and helpful notes on calibration/service procedures***

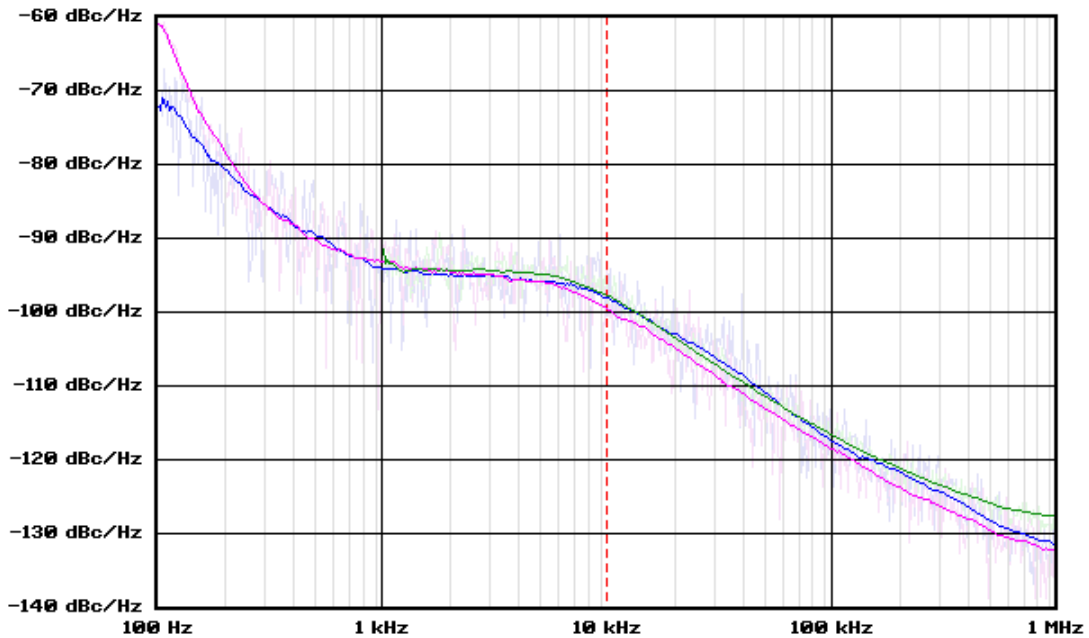
The traces below were acquired with PN.EXE from the GPIB Toolkit, measuring the output of a Wenzel crystal oscillator whose phase noise is substantially lower than the analyzers' own. Typical examples of the 494AP, 494P, and 492P spectrum analyzers were compared. Minimum RF attenuation was set to 0 dB in all three cases, and 20 dB of carrier clipping was used.

Trace	Carrier Hz	Carrier dBm	dBc/Hz at 10000 Hz	Clip dB	Instrument
S/N B010388	100 000 000	8.00	-98.1	20	TEK 494AP
S/N B010845	100 000 000	8.00	-99.6	20	TEK 494P
S/N B055692	100 000 000	8.00	-97.8	20	TEK 492P

The 494P appears noisier close to the carrier, but this is actually a consequence of its broader 30-Hz RBW specification compared to the 494AP's 10-Hz minimum bandwidth. The 30-Hz filter skirt, and not the LO phase noise, is responsible for the observed performance at offsets below about 300 Hz.

At offsets of 10 kHz and beyond, all 49x/275x analyzers should generally perform within +/- 5 dB of these traces. All three analyzers meet Tektronix's rather-loose PN specifications easily.
